Appendix F

Structures Inspection Results

FACILITIES CONDITION ASSESSMENT REPORT

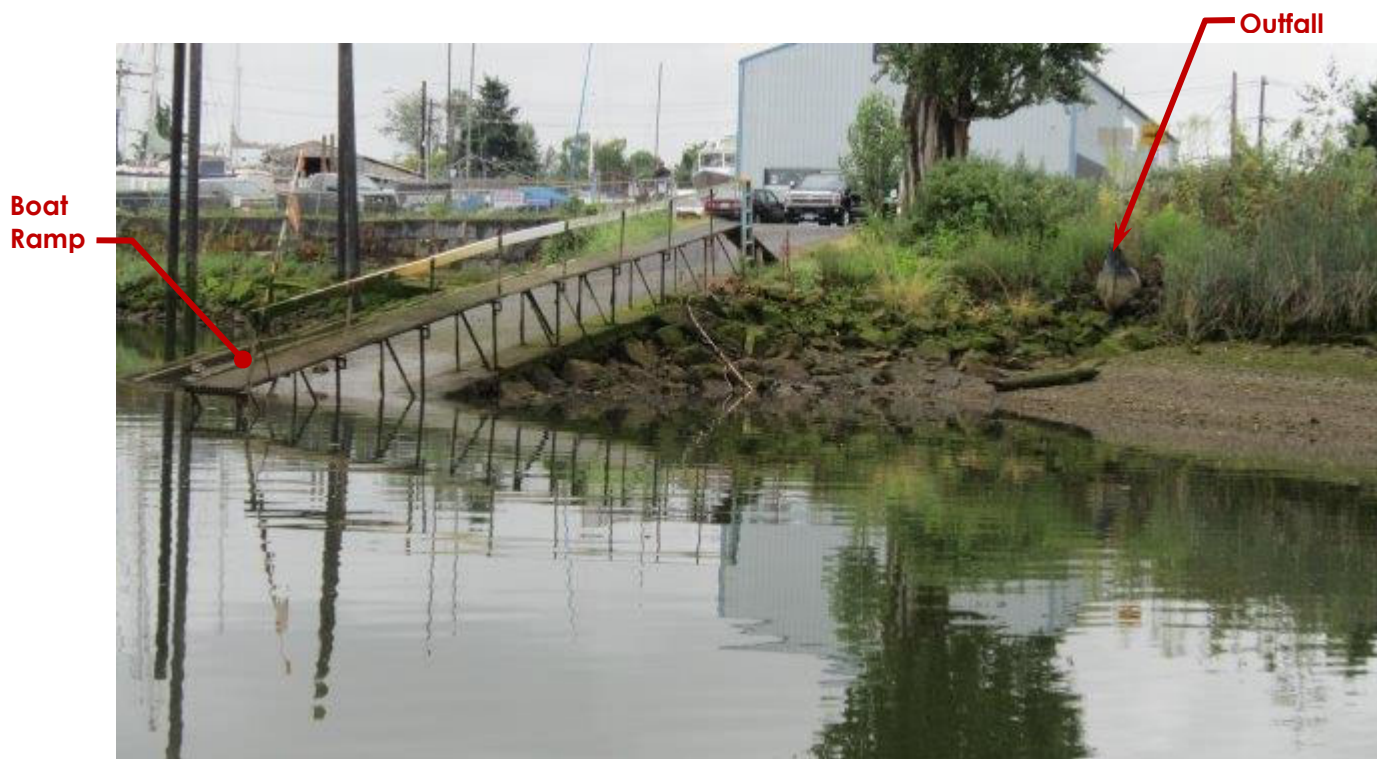
- Outfall with duckbill valve near the shoreline supported on a mound of quarry spalls (Photos 1 to 4).
- Approximately 24" diameter concrete pipe supported by quarry spalls and apron.

Photo 2215-03: Outfall (Looking Southwest)

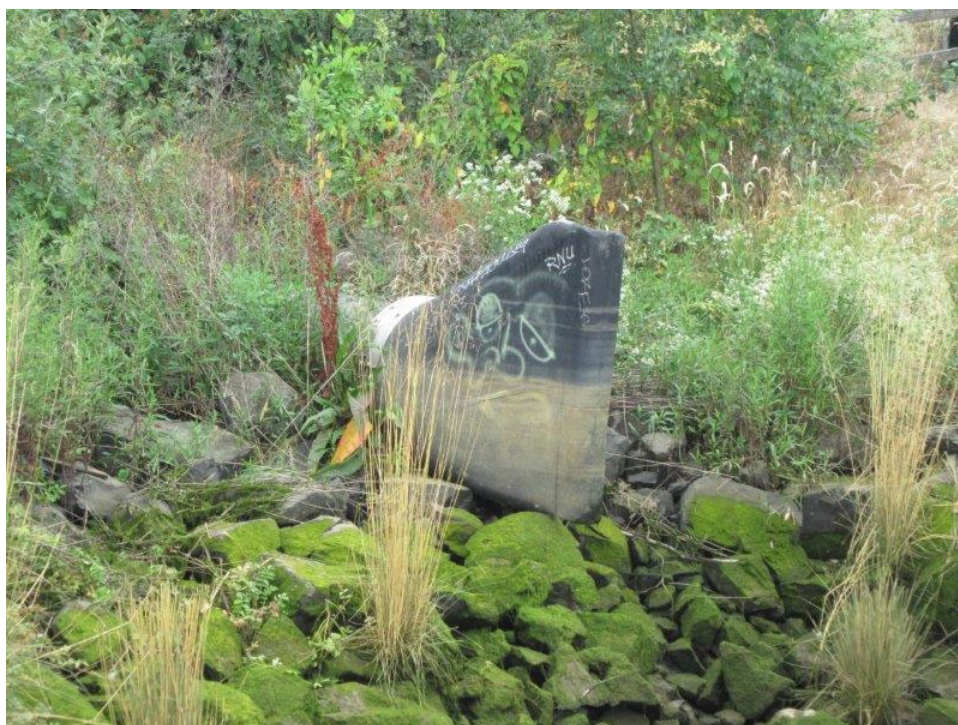
Photo 2215-03: Outfall Close Up

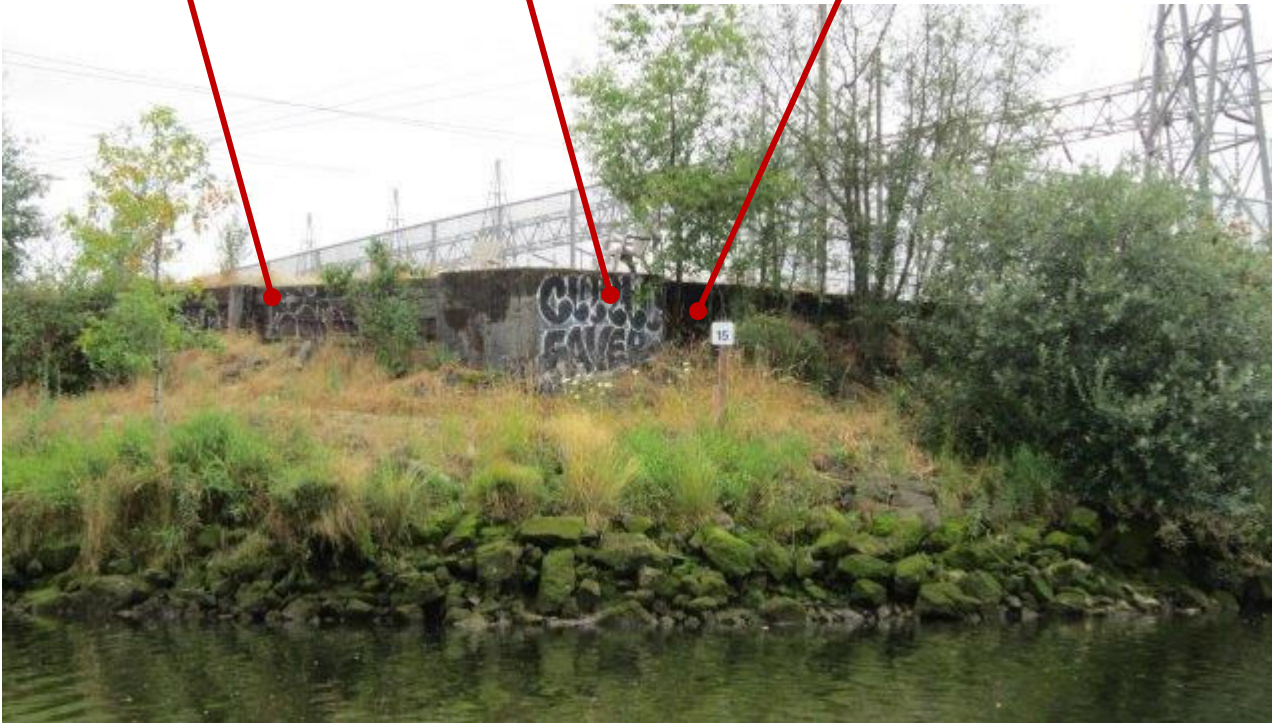
Photo ST06-01: West Shoreline Bulkhead South End

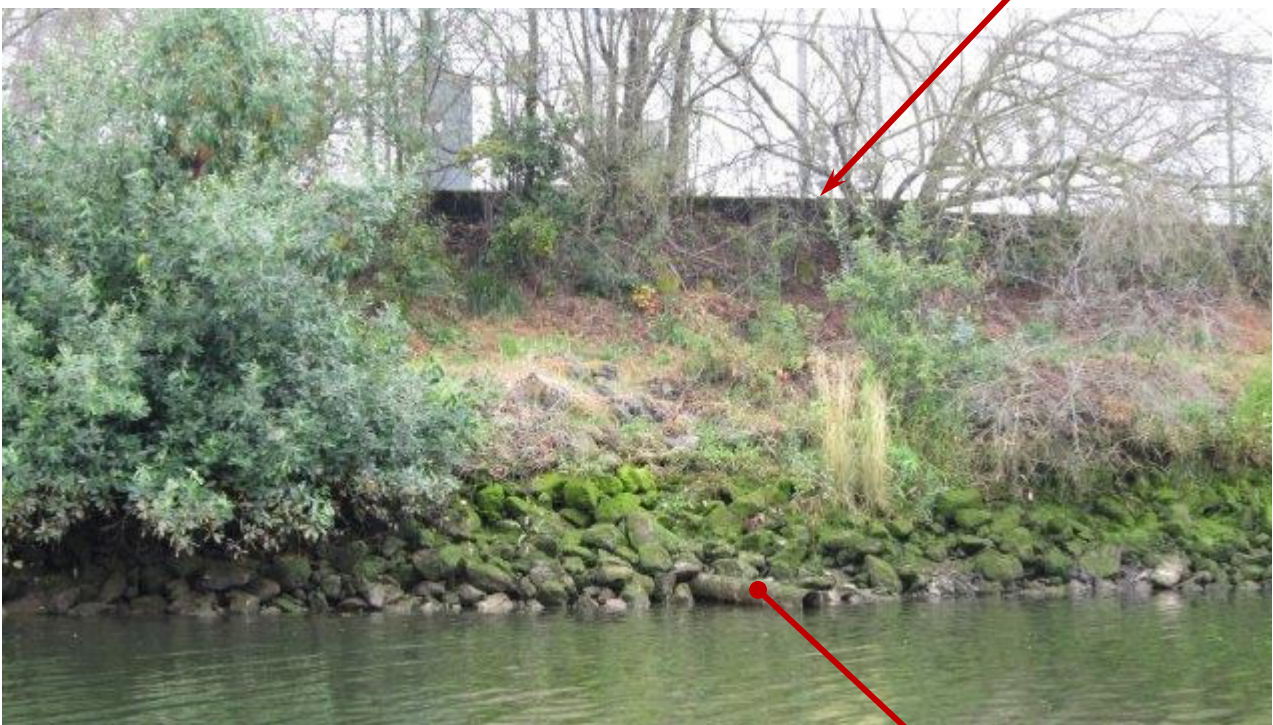
Photo ST06-02: West Shoreline Bulkhead

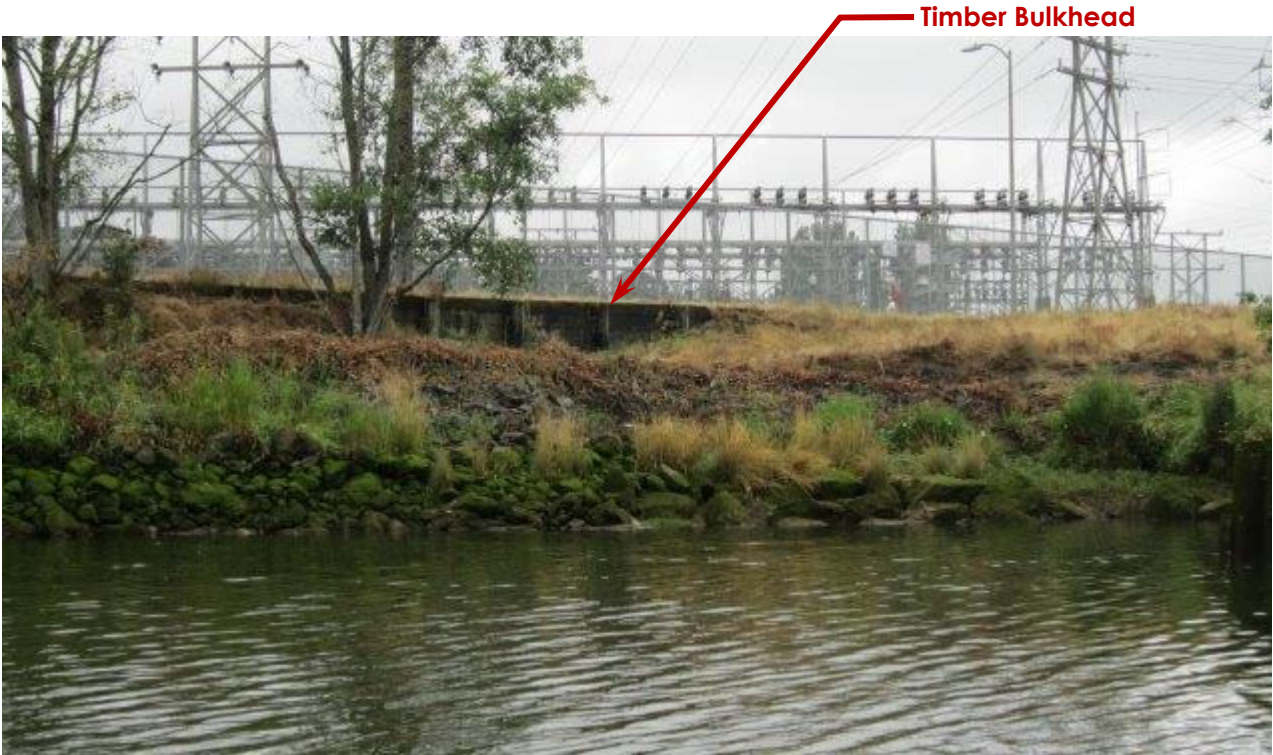
Photo ST06-03: West Shoreline Bulkhead

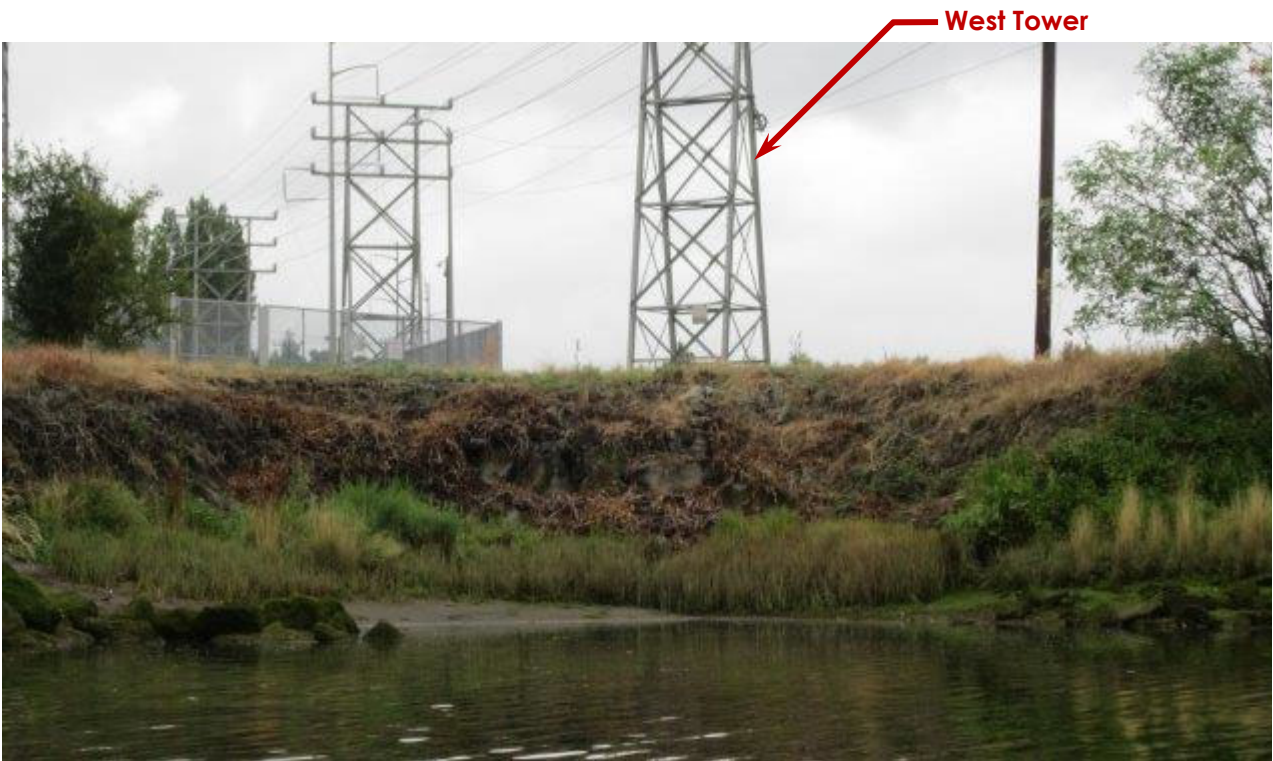
Photo ST06-04: West Shoreline North End

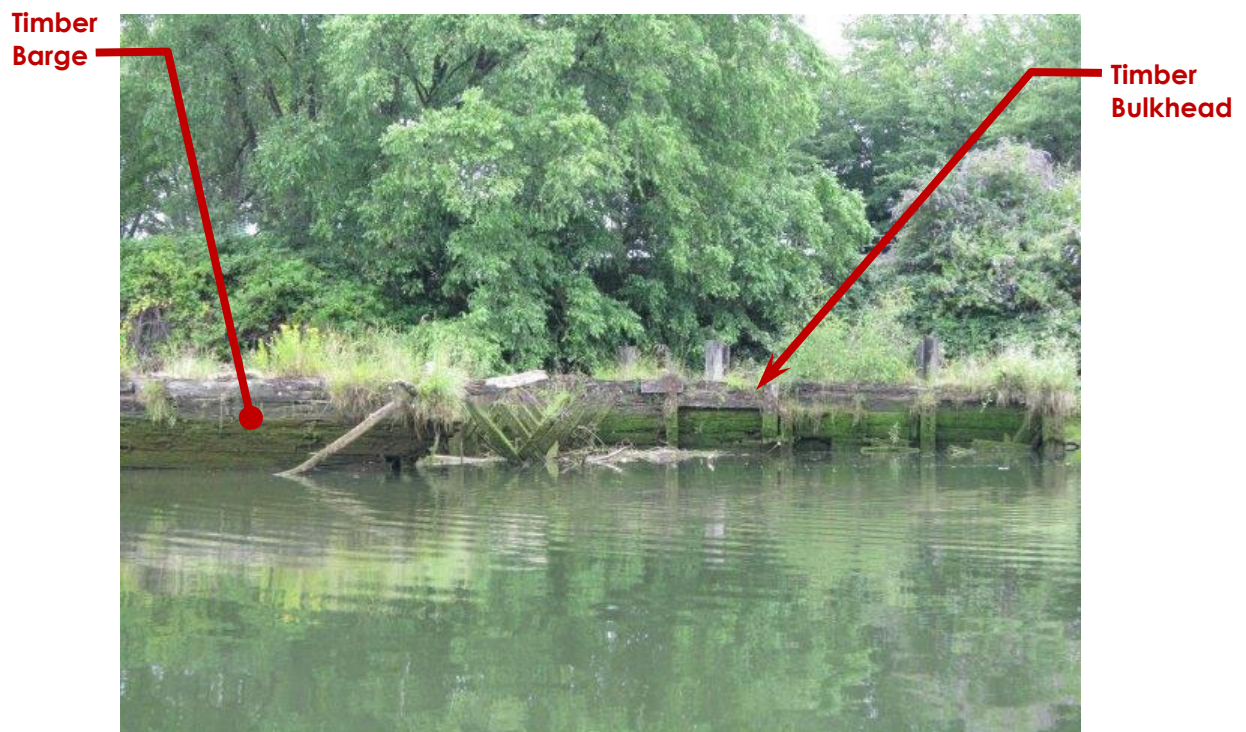
- Timber soldier pile and concrete panel lagging (Photo 1 and 2).
- Missing timber soldier piles in front of the concrete lagging. It appears that the south end of the wall is tied back or connected to a steel sheet wall. Large cracks throughout the concrete panel. Wall is in poor condition.
- Derelict timber barge or boat hull (Photos 1 and 3). The hull appears to be intact. Condition of the timber is unknown.
- Timber soldier pile and timber lagging (Photo 3).
- Missing, broken, or unfound timber piles and lagging.

Photo ST09-03: Timber Barge and Bulkhead (Looking East)

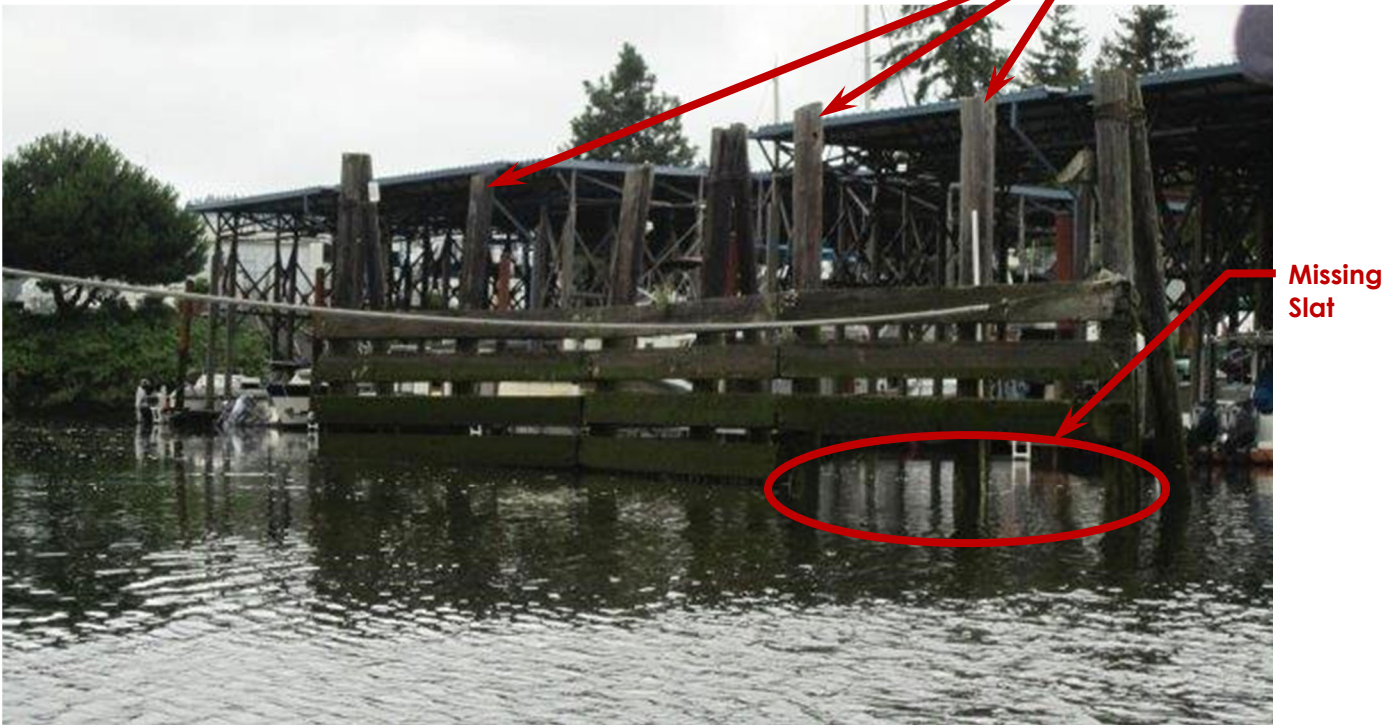
Photo ST13-01: Breakwater (Looking Northwest)

- Seven (7) sets of vertical and battered (toward the north) timber piles and horizontal timber slats (Photos 1 to 3).
- The piles appear to be in good condition, except several battered piles and slats are missing (Photos 1 and 2).
- Members are covered with moss within the tidal zone.
- Wood treatment is worn, but appears to be in good condition (Photo 3).

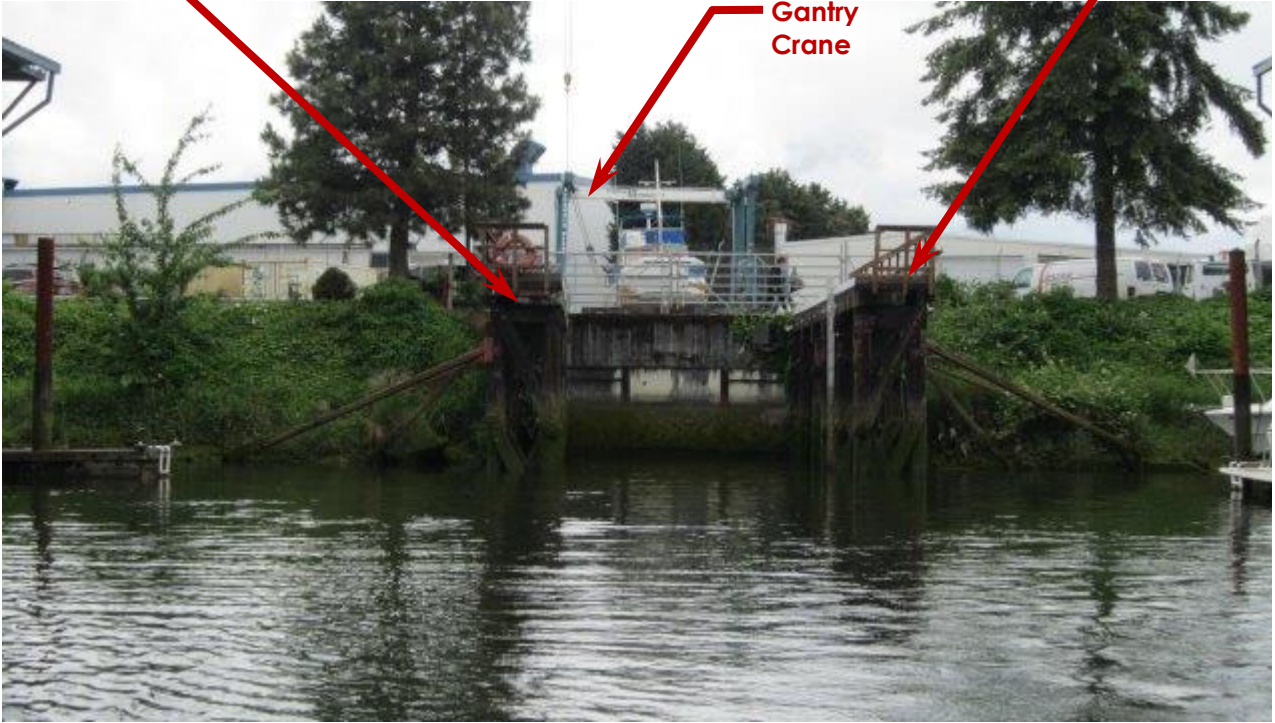
Photo ST14-01: Boat Lift (Looking West)

- Traveling gantry crane (east to west).
- Two (2) crane runways (north and south ends) each supported on offshore piers.
- Each pier consists of six (6) bents of braced (north to south) heavy timber piles and framing. No bracing in the east-west direction was observed.
- Steel soldier pile and concrete panel lagging bulkhead.
- The piles and framing appear to be in good condition, except for moss growth within the tidal zone.
- Preservative treatment on the timber piles and framing is worn, but appears to be in good condition.
- It appears that several steel bracings were added to the braced bents to provide additional lateral stability.
- The condition of the concrete bulkhead could not be closely observed. Appears to be in good condition except for corrosion on the steel piles and moss growth in the tidal zone.

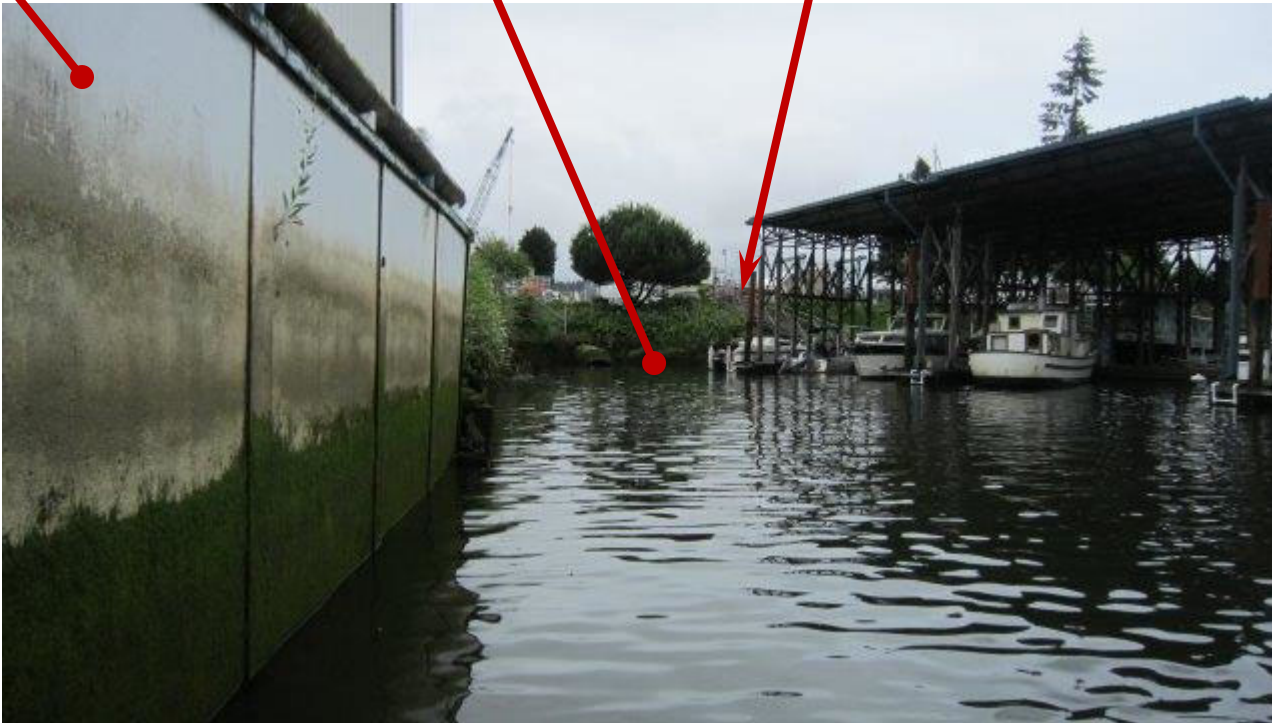
Photo ST15-01: South-most Float (Looking West)

- Concrete bulkhead along the west bank (Photo 1). The bulkhead was not accessible, therefore not observed.
- Four (4) gangways leading to the floats (Photos 1 and 2). The gangway was not accessed, therefore not observed.
- Four (4) parallel covered docks each with connection primary floating walkways.
- Timber float guide piles.

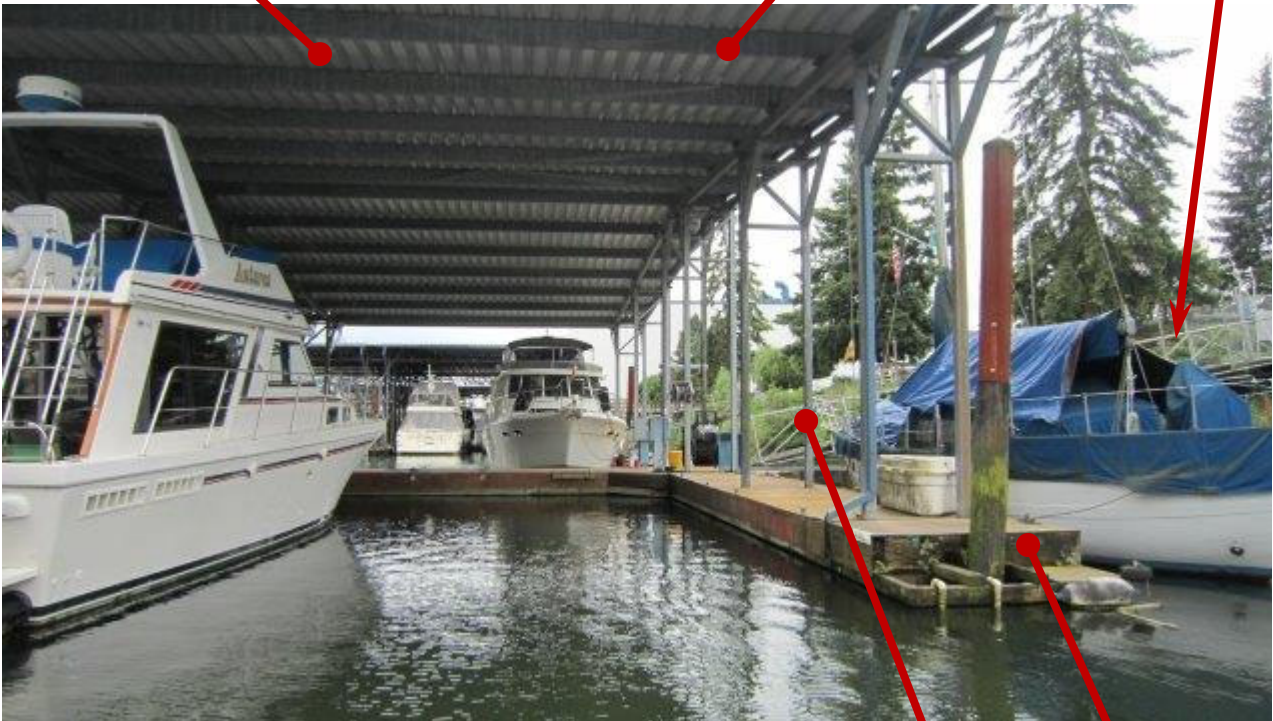
Photo ST15-02: Floats (Looking South)

- The guide piles are timber piles with a steel sleeve filled to the upper section (Photos 2 to 4, 6 and 7).
- The guide piles are covered in moss around the tidal zone but appear to be in good condition (Photos 2 to 7).
- The preservative treatment on the piles are worn but appear to be in good condition (Photos 2 to 7).

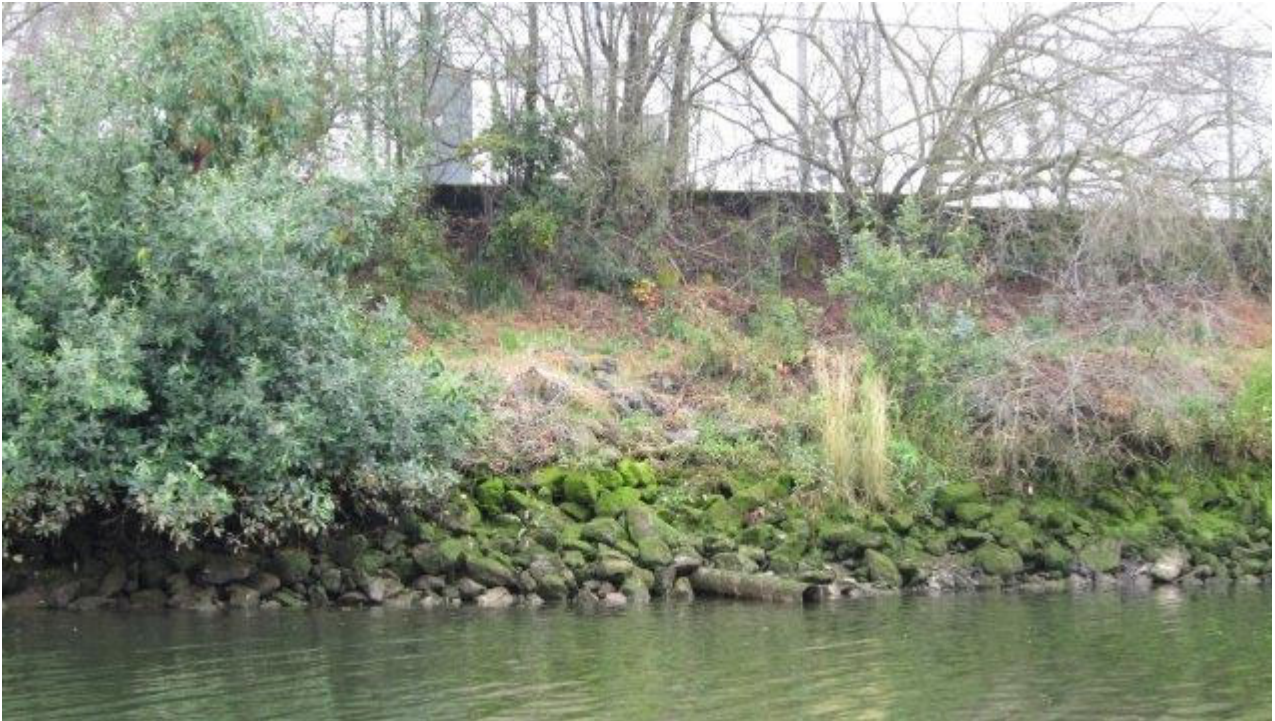
Photo 2098-01: Outfall (Looking West)

- Corrugated steel pipe projecting several feet beyond the shoreline surrounded by riprap (Photos 1 and 2).
- Moss growth around the pipe (Photos 1 and 2).
- Pipe size, material, and support condition were not observed.

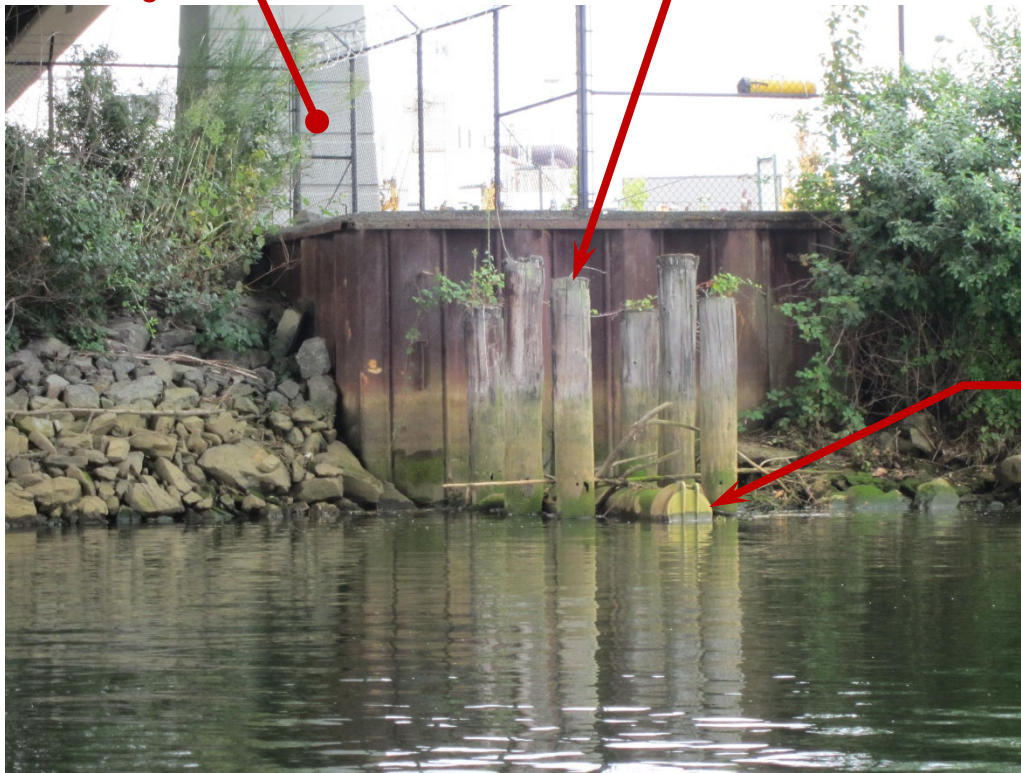
3032-01: Outfall Structure (Looking East)

- The outfall is located under and almost directly west of the South Park Bridge south pier. It projects several feet out of a 3-sided steel sheet pile bulkhead, and the projection is protected by three timber piles on the north and south sides. (Photos 1 and 2)
- The toe of the shoreline around the bulkhead is protected with riprap; however, support for the pipeline could not be observed.
- The pipeline size, material, and the condition, as well as the condition of the flap gate and timber piles, could not be observed.

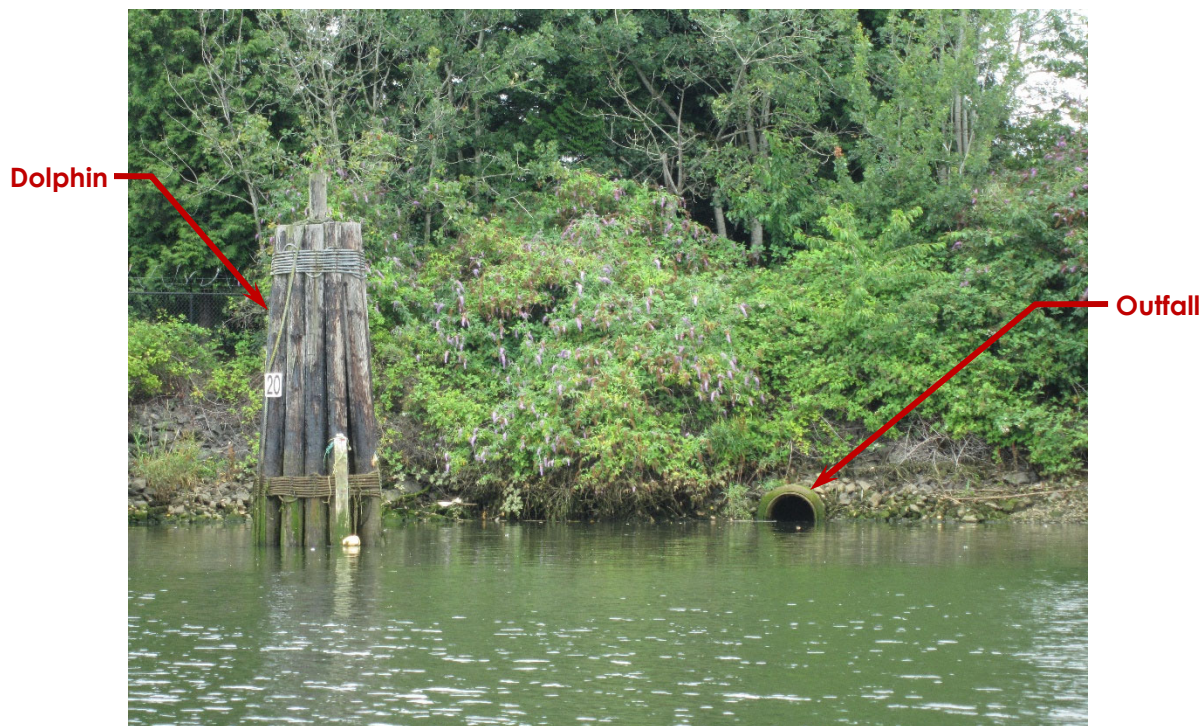
Photo BDC-1-01: Outfall South of Dolphin (Looking East)

- Outfall is encased with concrete and projects slightly beyond the shoreline. It is surrounded with riprap (Photos 1 and 2).
- Pipe size, material, and support condition were not observed.

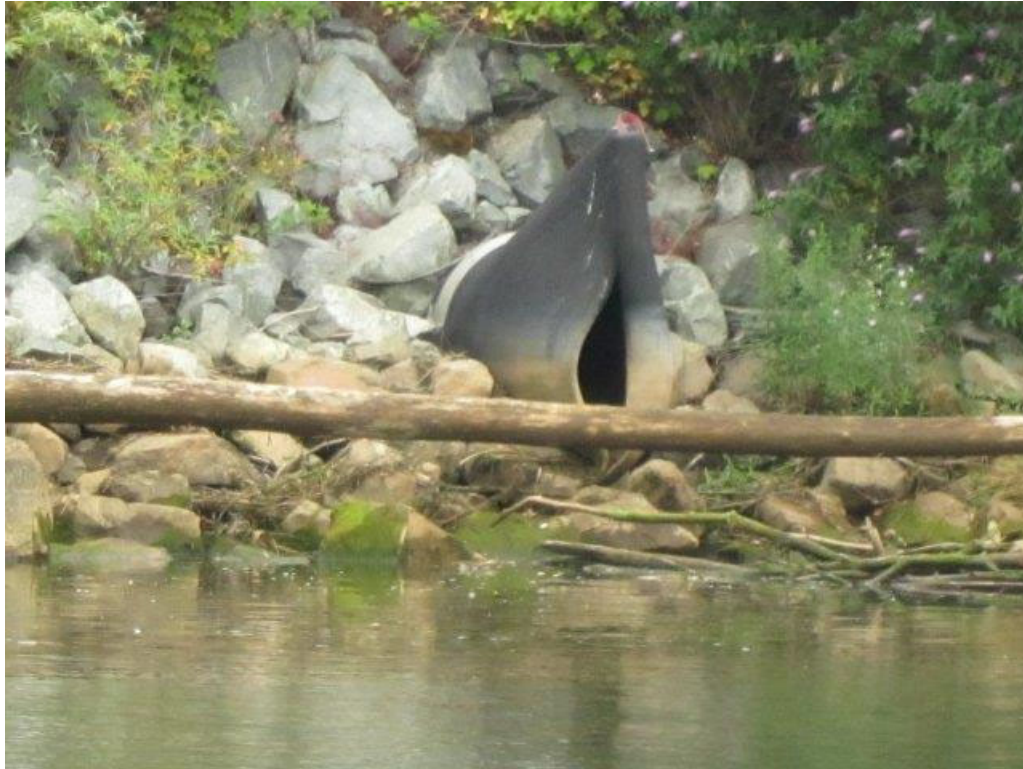
Boeing 1-01: Outfall North of Building

- Outfall with duckbill valve situated near shoreline, surrounded with riprap protection (Photo 1).
- Pipe material, size, and condition are unknown.
- Outfall is located at the north end of Boeing Plant 2 Building (Photo 2).
- Lower half of duckbill valve is open.

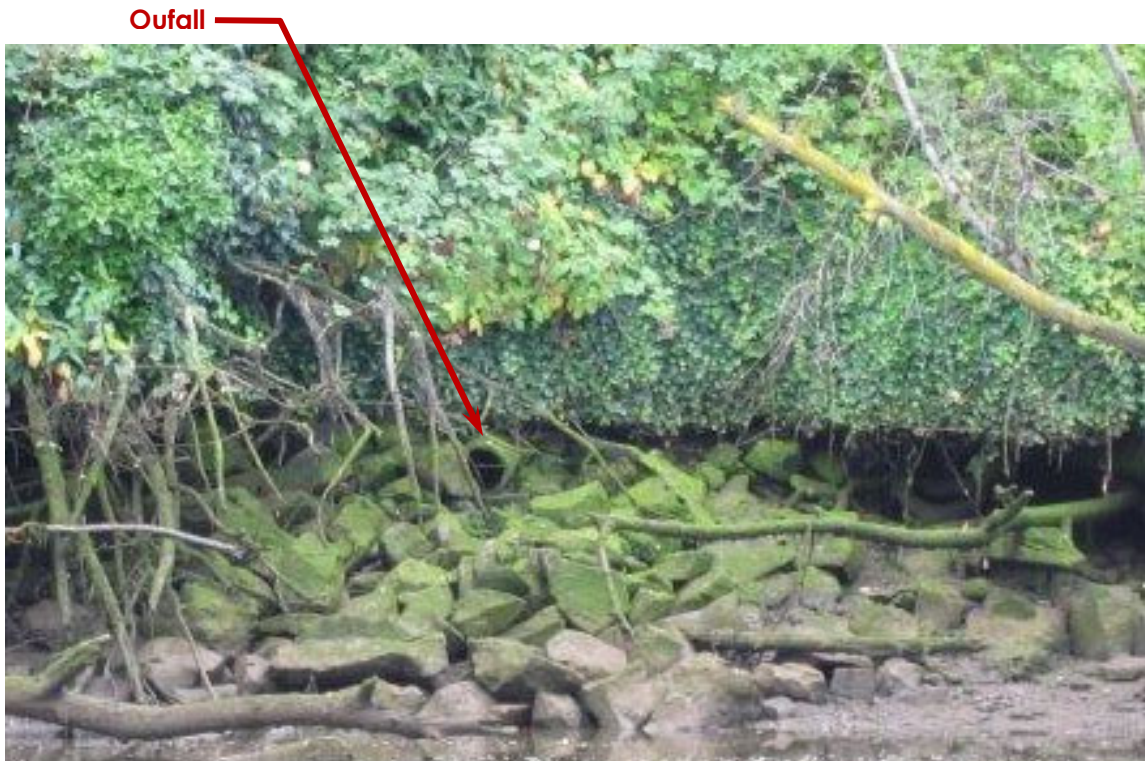
Photo SP3-02: Close Up of Outfall

- Outfall projects into the shoreline and is supported on a mound of riprap (Photos 1 and 2).
- Size, material, and condition were not observed closely.
